Danish Windmill Put a New Spin on this Old Mill

Restoration Project Portfolio- February 2017

Conditions Report –Danish Windmill Restoration Project Estimate | April 2016 B.E. Hassett Millwrights

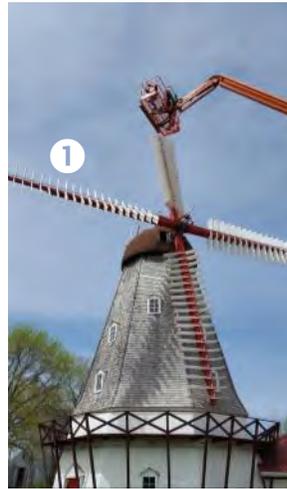
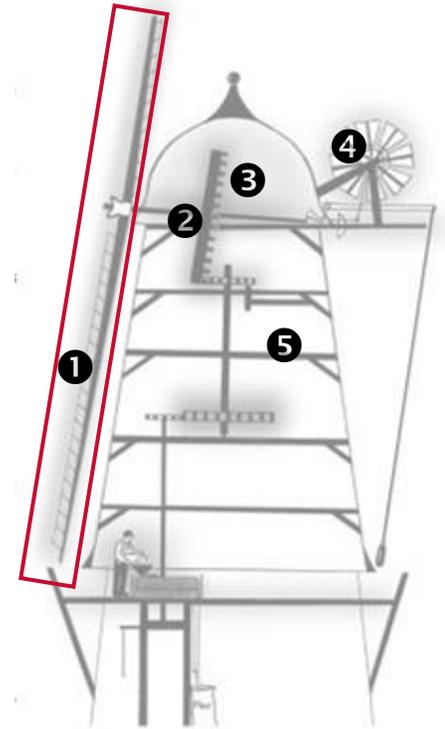
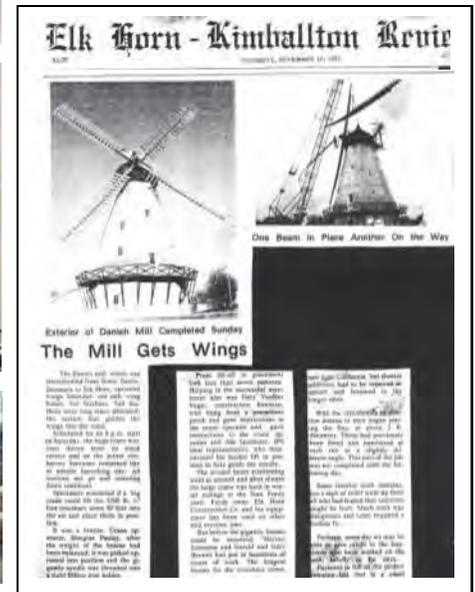
1 Dismantling and Removal of Existing Sails

The two 67 foot long timbers of the Danish Windmill sail cross arms weigh 3,500 pounds each and are 80 feet in the air. Wood rot in the timbers posed a major safety concern and jeopardized the integrity of the structure especially in the event of heavy snow.

The 88 white shutters were removed from the sails.

▲ The installation of the wings (sails) in November 1976 marked the completion of the Windmill's exterior restoration.

Sails -The sails date back to the Windmill's arrival in Elk Horn forty years ago. They've been repaired and patched in the past but now need to be replaced due to wood rot in the polls near the hub.

1 Sails- Rear Sail Stocks have significant rot at the poll end (hub) and are in need of replacement.
The existing sails are approximately 40yrs old and have seen past repairs. The overall length of the sails is nearly 67ft, tip to tip.

The condition and weight of these timbers pose a safety risk to both persons and property in their present condition.

It is recommended that a plan be put in place to remove the sails from the mill by disassembly and wholesale removal so as to utilize the existing sail stocks as patterns.

It is further recommended that both of the sails be replaced at the same time, when funding is available to do so. Though the forward sails do not appear to be in as bad of condition as the rear set, it is likely they would need to be replaced in the near future given their age and exposure.

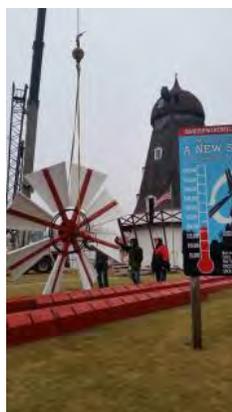
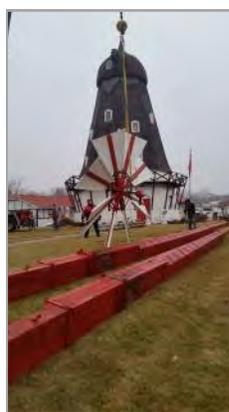
2 3 Wind shaft and brake wheel—Replace Timbers for wind shaft and repair brake wheel

The old wind shaft was removed and a new one will be constructed for installation in the spring.

2 Wind Shaft- Existing wind shaft has been repaired/patched at critical areas in the past.

A basic inspection shows rot and decay present at critical areas including the areas supporting the Poll end and Gudgeons. I currently have a wind shaft timber at my shop that was tapered and bored for the replacement of the existing shaft.

The arms of the brake wheel that secure the Gear to the shaft are rotten in critical areas at the clasp arm hub and arm ends. The arms of the gear need to be replaced.

With the weight of the poll and sails, and if the mill is to be operated, it is highly recommended that the current shaft be replaced. New sails should not be installed utilizing the old shaft for support.

2. Wind Shaft- Removal of existing shaft. Supply new white oak wind shaft. Fit Poll end, and install Back into Cap frame. This component of the proposal also includes the reassembly of the spider coupling and mechanism.

3. Brake Wheel- Removal of Existing Brake wheel. Install new gear. Set up and adjustment of brake band. New brake wheel will utilize existing cogs if possible. Gear will be constructed in my shop and fitted to new wind shaft and periphery of gear "trued" to insure proper and effective operation of brake band.

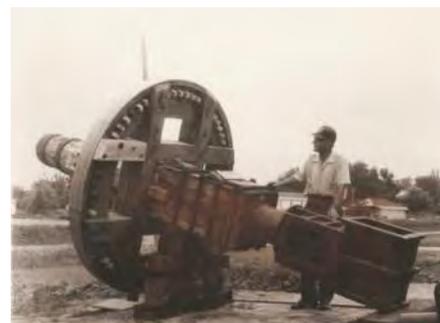
Shown above- Harvey Sornsen inspects the wind shaft when it arrived from Denmark forty years ago.

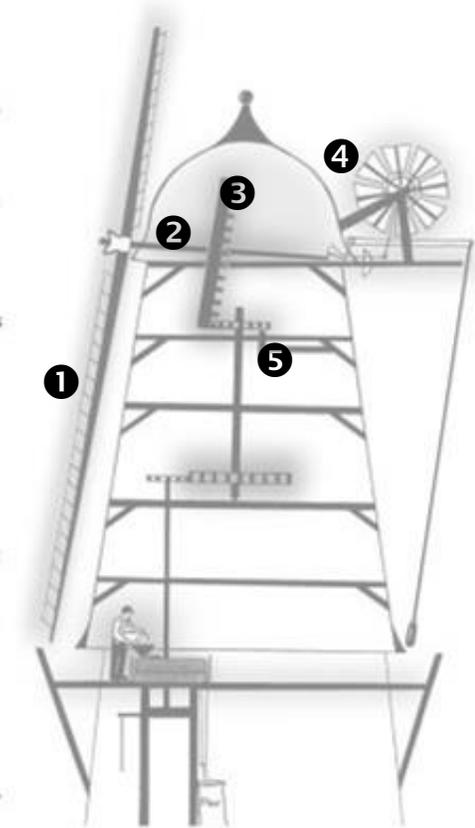
▲ **New Wind Shaft**—The existing wind shaft has been repaired/patched at critical areas in the past. Knowing that at some point it would need to be replaced, we purchased the timber and had it tapered and bored to be ready when it was needed and that time is now.

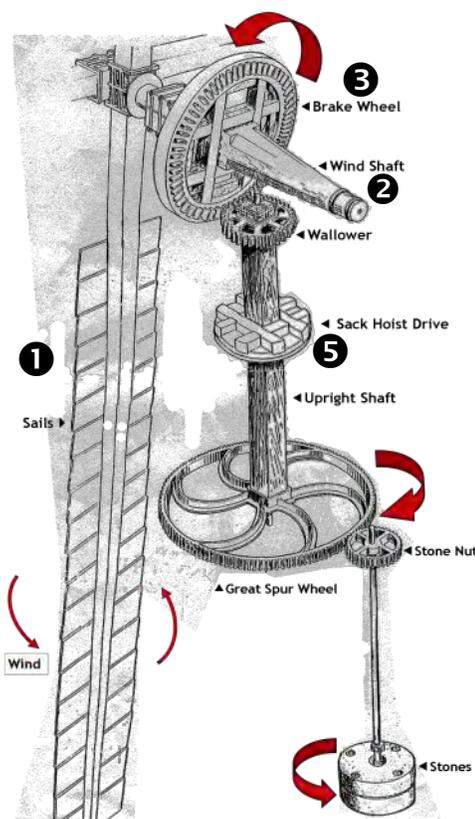
▲ **New Sail Cross Arms**—A long lead time is required on the purchase of the new set of timber sails so they were ordered in May. Main stock lengths are 67' in length and 12x12 In section. The timbers were transported from Oregon to Kentucky in August where they are being dried at Hasset's shop to an "air dried" moisture content, then treated with preservatives.
