Danish Windmill Put a New Spin on this Old Mill

Restoration Project Portfolio- February 2017

Conditions Report –Danish Windmill Restoration Project Estimate | April 2016 B.E. Hassett Millwrights

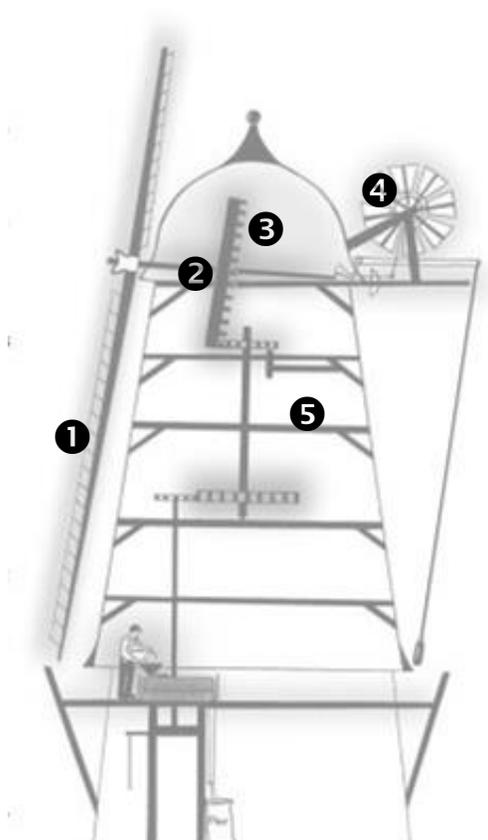
Anatomy of the Windmill & Project Elements

2 3 Wind shaft and brake wheel—Replace Timbers for wind shaft and repair brake wheel

4 Fan tail and frame and Cap frame—Repair the fan tail, treat cap frame for rot

5 Sack Hoist — (illustration only, no photo) Replace friction drive pulley for sack hoist

The old wind shaft was removed and a new one will be constructed for installation in the spring.
